TECHNICAL NOTE No: MECH. ENG. 297

CONTINUOUS ROD WARHEAD LETHALITY  
TRIALS AGAINST B.29 AIRCRAFT WINGS  
(3/16,  $\frac{1}{4}$  AND 5/16 inch SQUARE-SECTION RODS)

CONTINUOUS ROD WARHEAD LETHALITY TRIALS AGAINST  
B.29 AIRCRAFT WINGS  
( $3/16$ ,  $\frac{1}{4}$  AND  $5/16$  INCH SQUARE-SECTION RODS)

SUMMARY

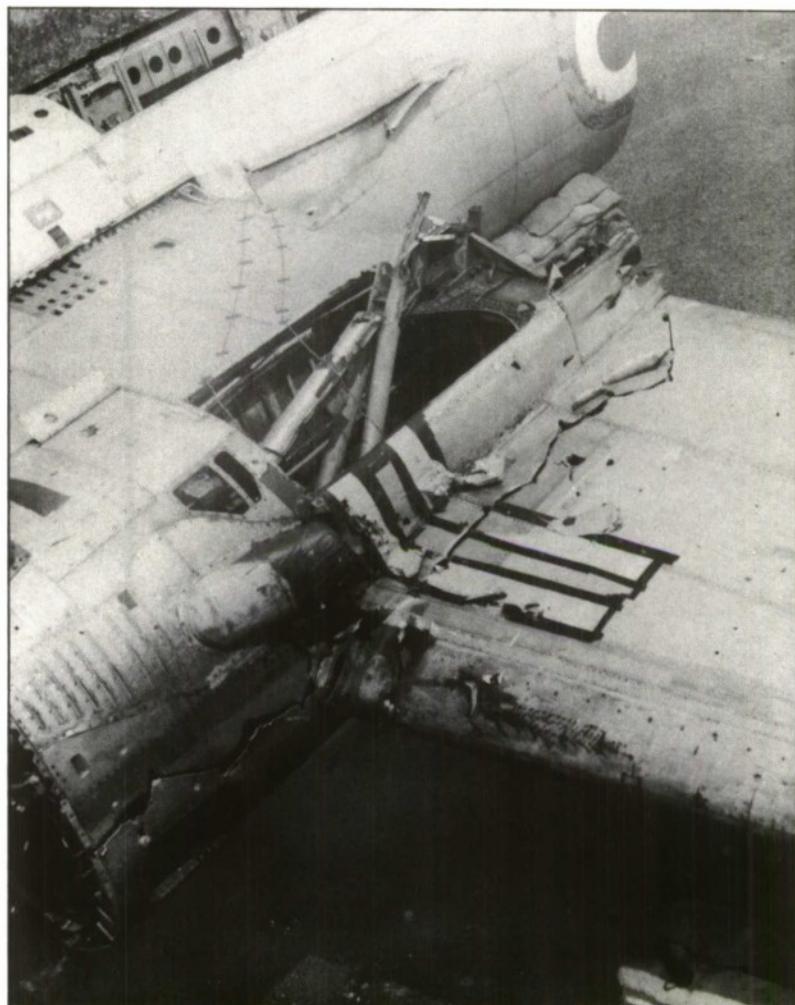
**FIG.8. FIRING 3. ROD DAMAGE TO LOADED PORT WING  
(1/4 inch ROD, STATION 225)**

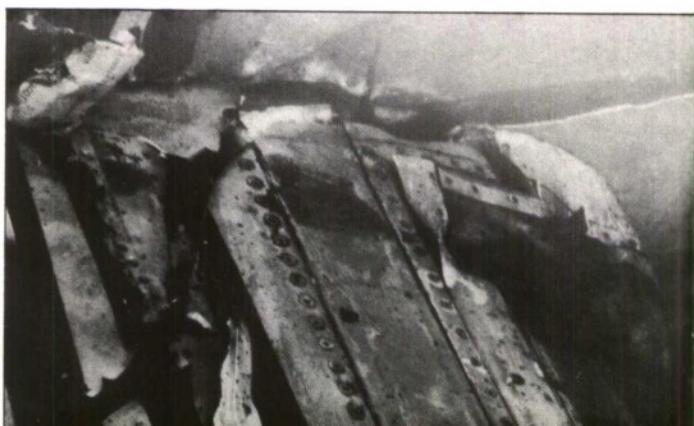
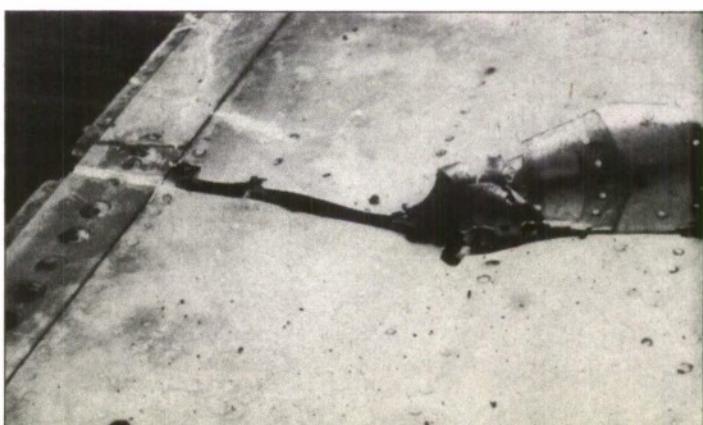
FIG.9a. FIRING 4. ROD DAMAGE TO LOADED PORT WING  
(1/4 inch ROD, STATION 225, 1½ g FLIGHT LOADS)

FIG.9b. FIRING 4. ROD DAMAGE TO SPAR BOOMS  
(1/4 inch ROD, STATION 225, 1½ g FLIGHT LOADS)

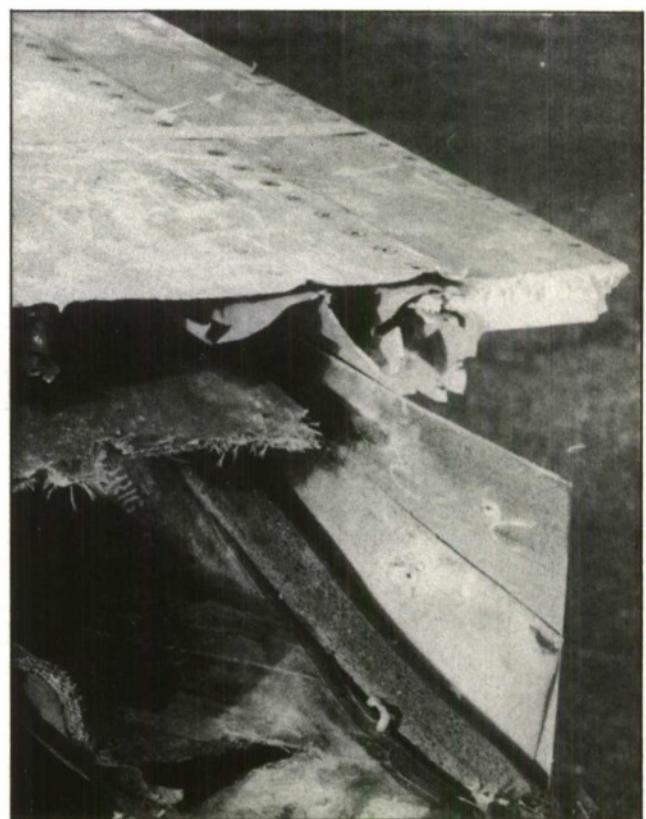
FIG.12a. FIRING 9. ROD DAMAGE TO LOADED STARBOARD WING  
SHOWING FAILURE (3/16 inch ROD, STATION 442)

FIG.12b. FIRING 9. SEVERED SPAR BOOMS  
(3/16 inch ROD, STATION 442)

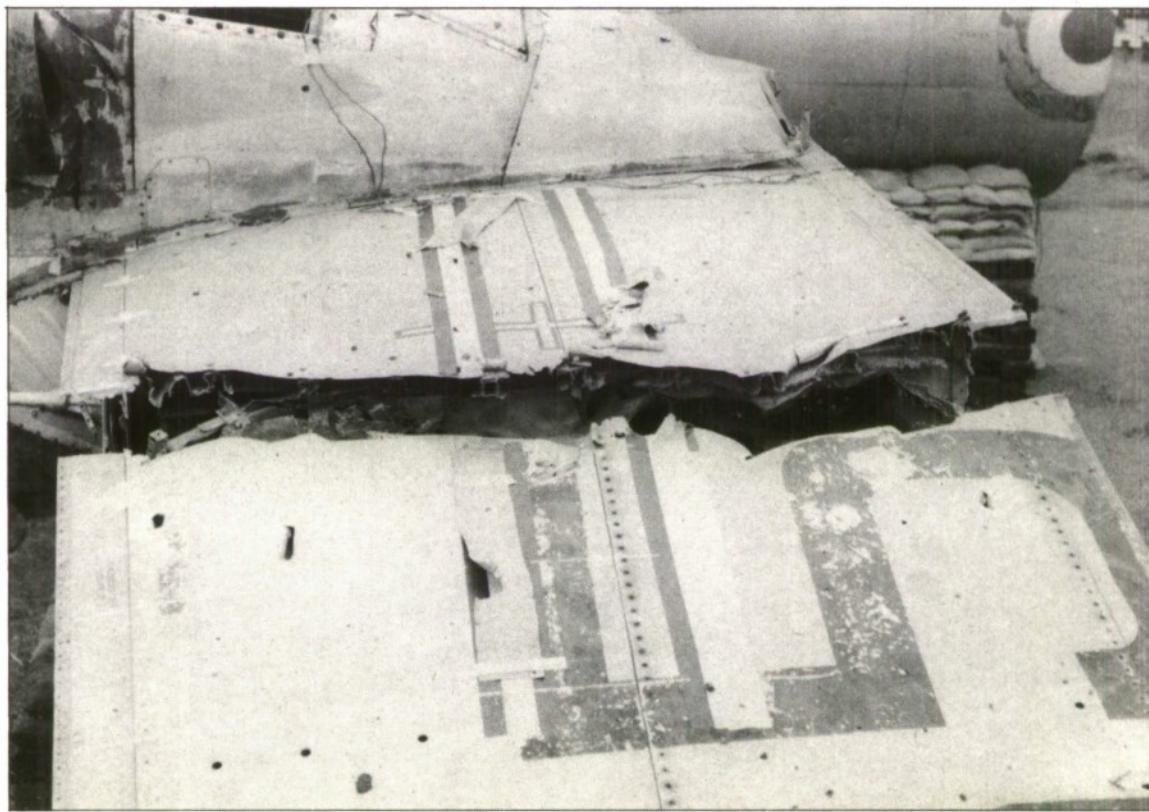
FIG.13b. FIRING 6. DAMAGE TO WING LOWER SURFACE LOOKING INBOARD (1/4 inch ROD, STATION 442)

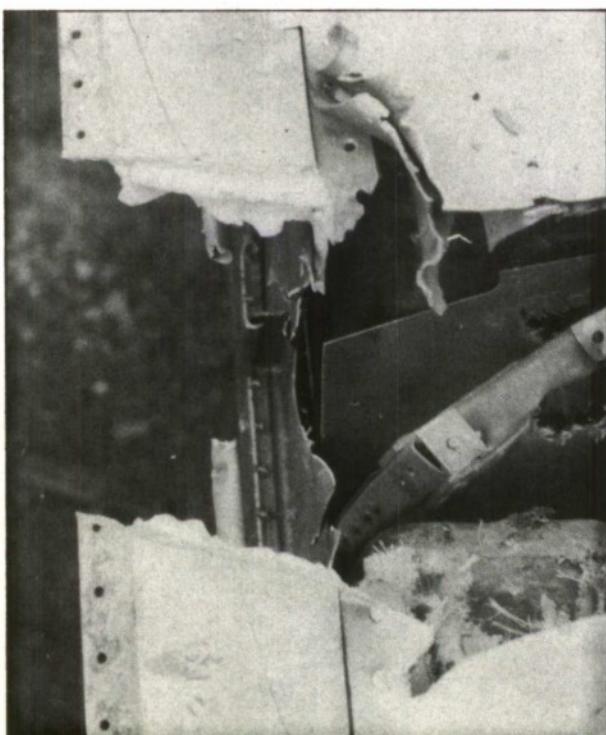
FIG13d. FIRING 6. SEVERED LOWER SPAR BOOMS  
( $1/4$  inch ROD, STATION 442)
